Rail Accident Investigation Branch

# Rail Accident Report

**Electrical arcing and fire under a train near  
Windsor & Eton Riverside  
30 January 2015**

Report 18/2015  
October 2015

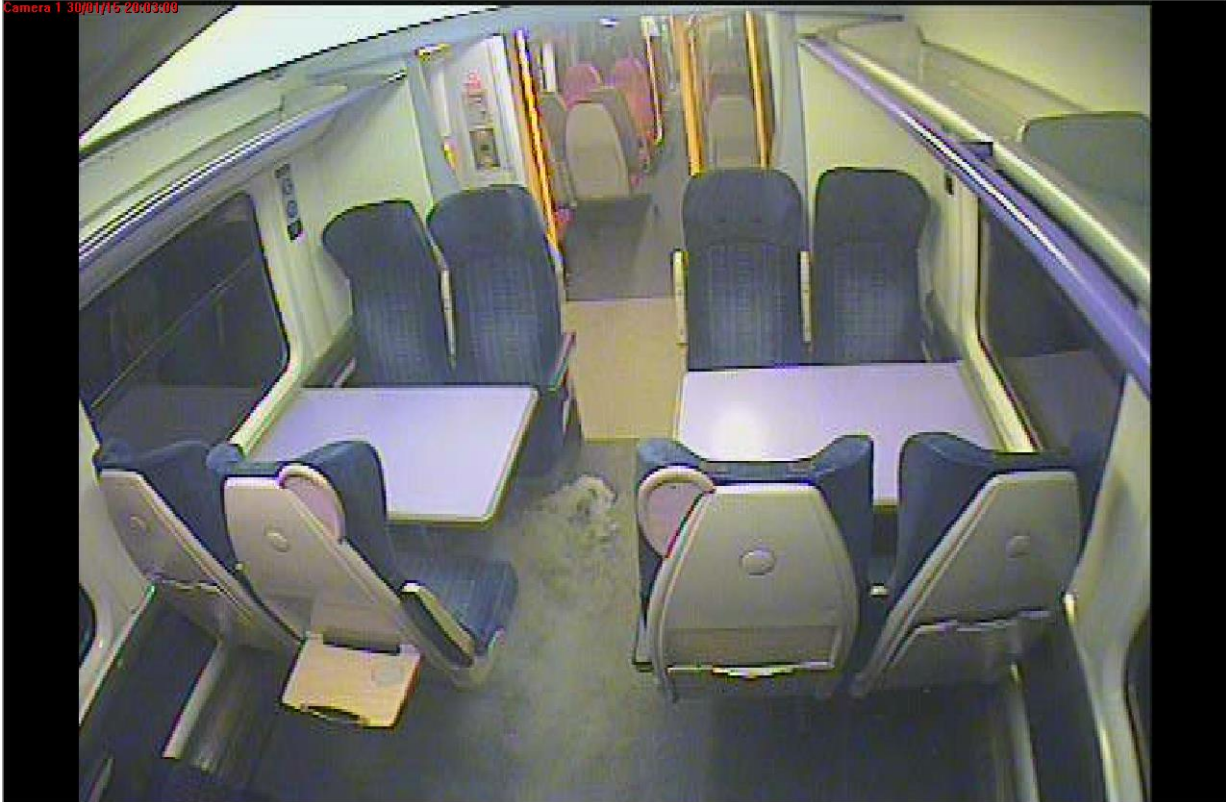
- 31 The guard and driver began to discuss what to do next. They could see that, although the flashing had stopped, clouds of smoke were continuing to billow from under the sixth carriage, and were entering the cab where the guard was. The guard opened the door to the saloon of the sixth carriage, and found that it was also full of smoke (CCTV shows that smoke began to emerge from the floor just over five minutes after the guard arrived in the cab, and eight minutes and twenty seconds after the train had stopped (figure 3)).

Figure 3: smoke breaks through the floor of carriage 67601

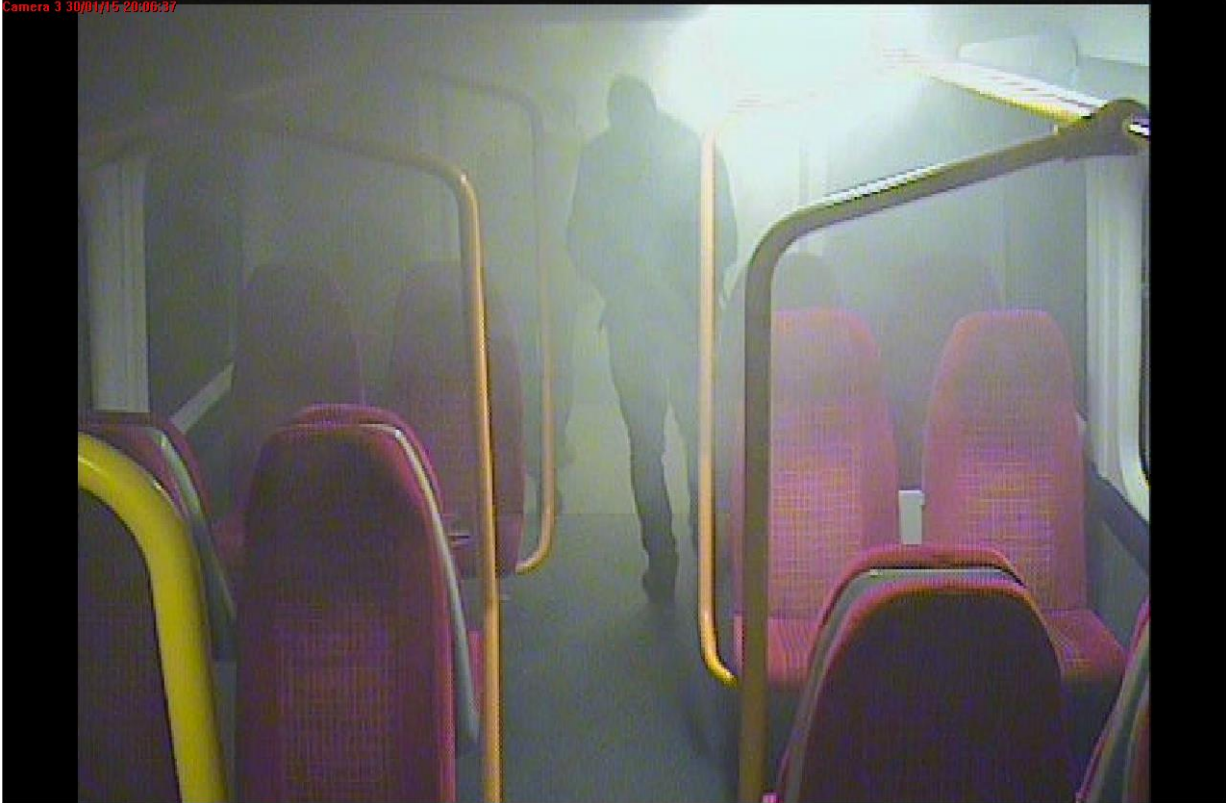
33 Three passengers went into the sixth carriage at about this time, and used their mobile phones to take photographs of the smoke-filled vehicle. CCTV shows that they retreated, coughing, to the seventh carriage after about one minute (figure 4).

Figure 4: Passengers taking photographs of the smoke in car 67601

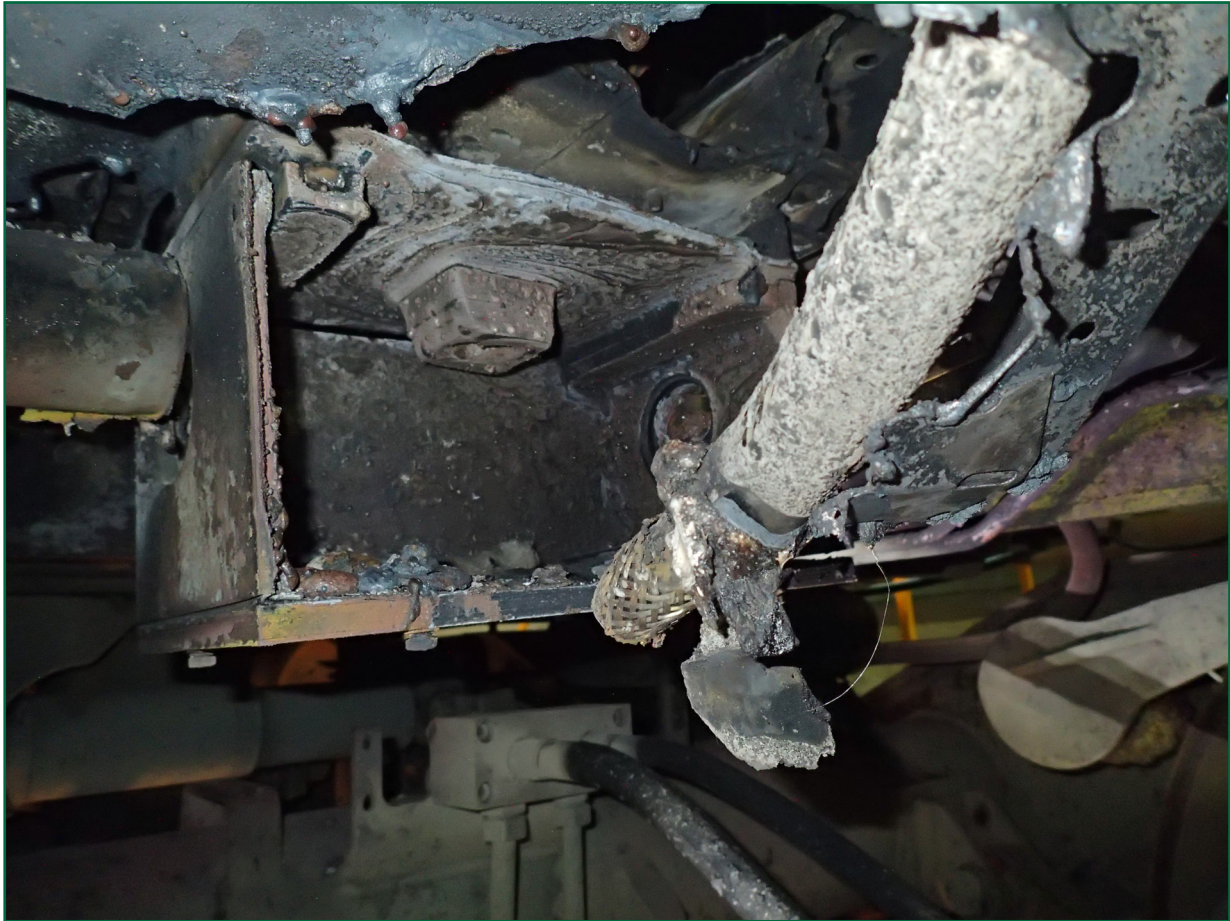
- 47 The RAIB examined unit 458501 at SWT's depot at Wimbledon on 2 February. The area under vehicle 67601 where the arcing took place is shown in figure 5, and the arrangement of the power cables is shown in figure 6a.

Figure 5: the area where the arcing took place, showing damage to the junction box, cables and structural members

- 48 Although, because of the nature of the event, much of the evidence had been destroyed, the origin of the arcing was almost certainly the joint where the two power cables from the collector shoes on each side of the carriage (the shoe cables) are connected to the cable which carries traction current through the unit (the bus line). The joint is mounted under the vehicle floor, close to the bogie on which the collector shoes are mounted. The construction of this joint is shown in figure 6b. It consists of a single zinc plated steel M16 hexagon head setscrew, 45 mm long, which passes through holes in the ends of the lugs which are crimped to the three cable ends, and is screwed into a through tapped hole in a boss which is welded to a plate, forming a bracket assembly. The joint also includes a plain washer and a helical spring washer. Alstom document FMI J06 ALST 0078 specifies that the setscrew should be tightened to 173 Nm.

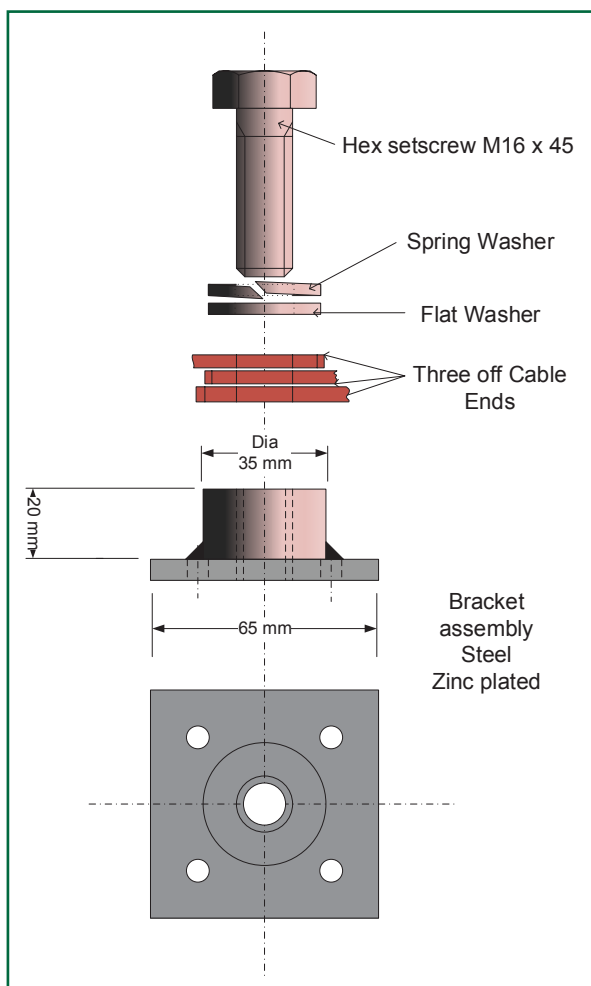
Figure 6b: details of the cable joint

- 70 The consultant concluded that it was likely that the failure of the cable joint was a result of the M16 screw failing to provide sufficient clamping force, because of an inadequate initial tightening and/or the use of a previously tightened screw.

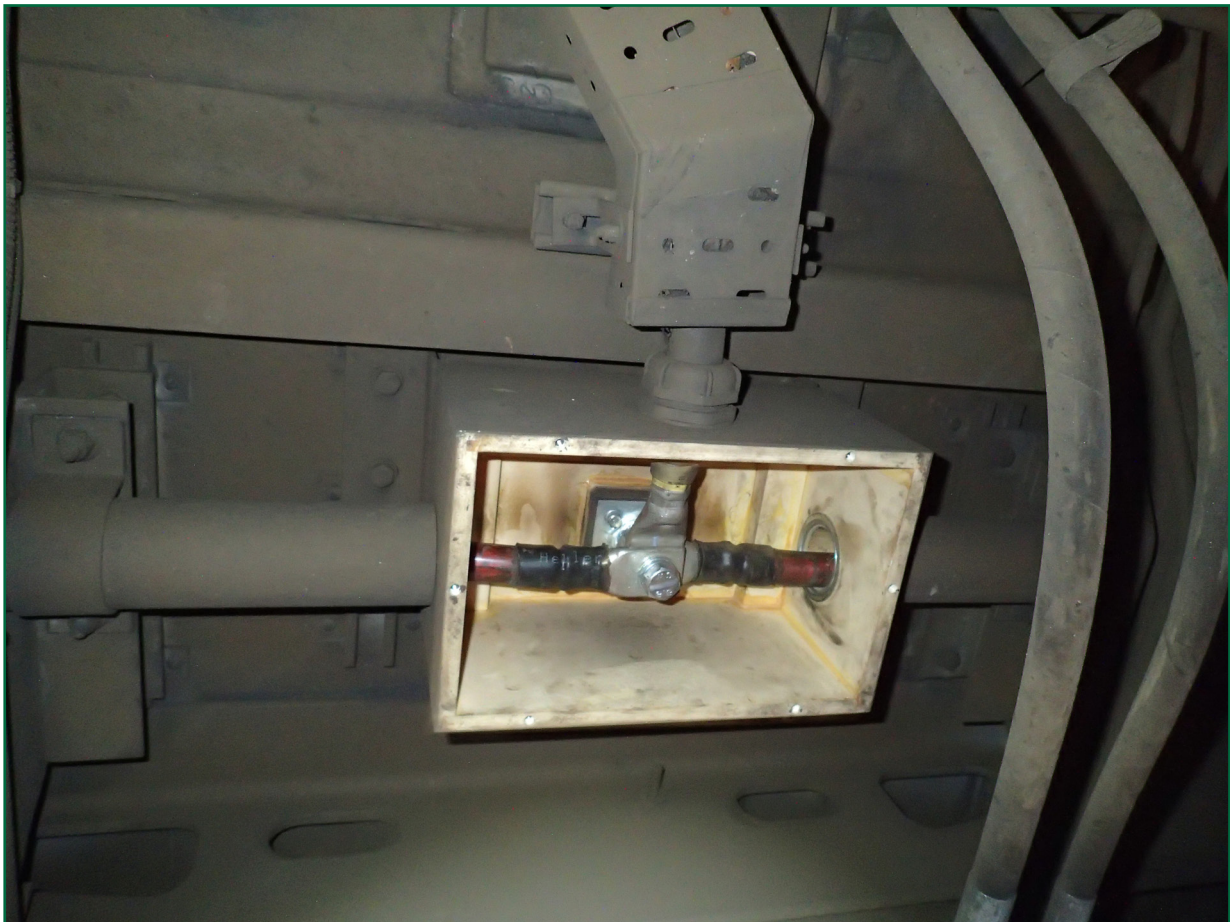
- 49 This bracket is bolted to a pillar of insulating material. The pillar is within a junction box made of the same material, MICAM EM42. This fire-resisting material is a filled epoxide resin composite with woven and non-woven glass reinforcement. The junction box is glued together, and has a lid (which is on the bottom when the junction box is mounted on the train). The lid is bolted in place with captive screws (figure 7).

Figure 7: The junction box (undamaged example: lid removed)

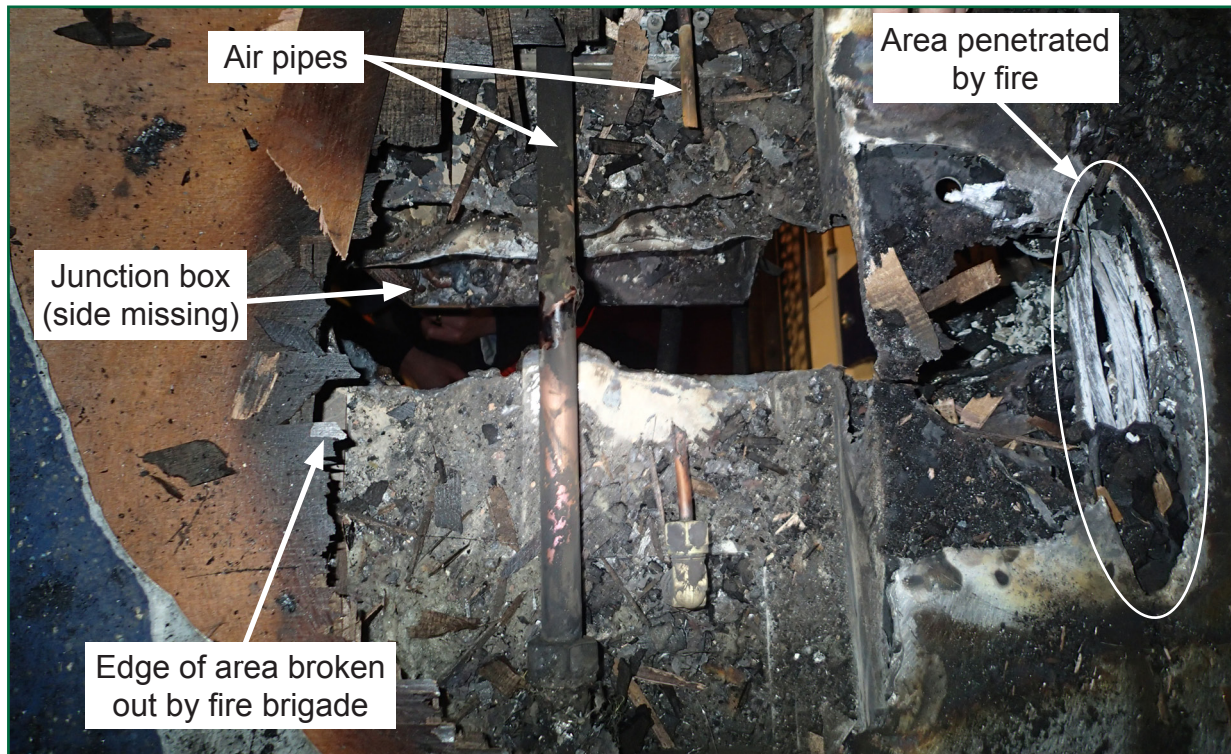
- 54 It was not possible to be certain exactly how much of the upper surface of the floor, and floor covering, had been burnt through by the arcing or by the subsequent fire, because of the action taken by the Fire Brigade to expose any smouldering areas. However, it seems likely that a large area was heavily charred and an area at least 150 mm by 30 mm was fully penetrated (figure 9).

Figure 9: Damaged area of floor, viewed from above

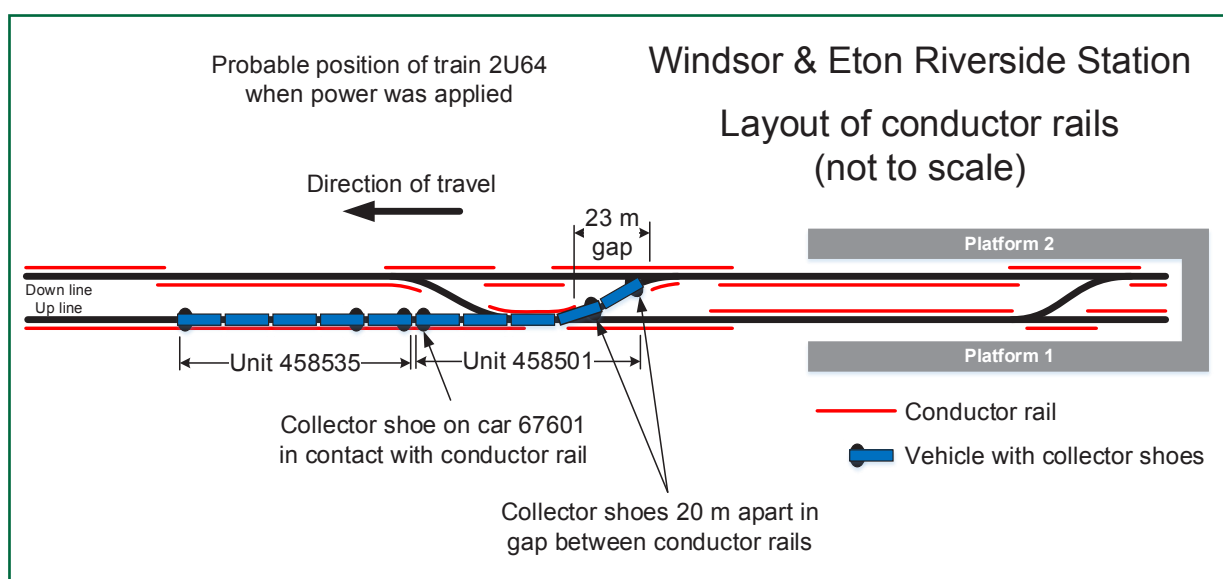
63 The initiating event for the violent arcing almost certainly occurred when the driver of the train applied power as the rear of the train was passing over the crossover from platform two to the up line. Because of the presence of the crossover, there is a gap of about 23 metres in the conductor rail for trains taking this route. The collector shoes on the rear two cars of the train are 20 metres apart. Therefore, for a short period, the only collector shoe on unit 458501 in contact with a conductor rail was the left-hand shoe on the leading vehicle, car 67601 (figure 10).

64 This meant that, for about half a second, a current of about 1900 amps (supplying all the traction motors on the unit) was probably passing through the loose joint. This initiated a powerful arc within the junction box, which burnt away the cable ends, creating heat and gas which raised the pressure inside the box, leading to an explosion and subsequent visible arcing (paragraph 22).

Figure 10: Layout of conductor rails and position of train at start of arcing
